## USAAMRDL TECHNICAL REPORT 72-12

### DESIGN STUDY OF REPAIRABLE MAIN ROTOR BLADES

Paul F. Maloney  
Carrol R. Akeley

July 1972

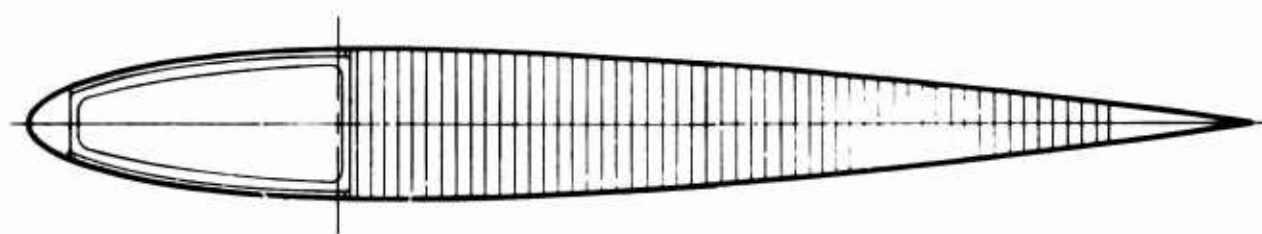
Figure 7. Configuration I, Repairable Rotor Blade Using UH-1 Structural Components.

#### DESIGN CONSIDERATIONS

1. MINIMUM CHANGE FROM CURRENT UH-1 BLADE.
2. FIBERGLASS SKINS PROVIDE SIGNIFICANT INCREASE IN REPAIRABILITY.
3. MINIMUM RESUBSTANTIATION REQUIRED.
4. UTILIZES EXISTING RETENTION.
5. SEGMENTED STEEL LEADING-EDGE SHEATH.
6. FIBERGLASS SPAR DOUBLER OUTBOARD.

SECTION A

SECTION B

This design, illustrated in Figure 7, makes maximum use of existing UH-1 blade structural components and yet provides a significant advance in repairability. The basic spar, trailing-edge spline, root end doublers, and leading-edge ballast are common to the current blade, while the skins, spar doubler, and leading-edge sheath are modified designs. Outboard of station 152, the skin consists of two layers of unidirectional glass fiber with a  $\pm 45$ -degree orientation with an inner and outer ply of 120 fiberglass cloth also with a 45-degree orientation. Inboard of this station, this skin is doubled in thickness; and again at the blade root, additional doubling plies are added. For inboard portions of the blade, the shear strength and stiffness exceed that of the current aluminum skin; while outboard, where the loads and the influence on natural frequencies are reduced, the skin properties are less than the current aluminum skin.

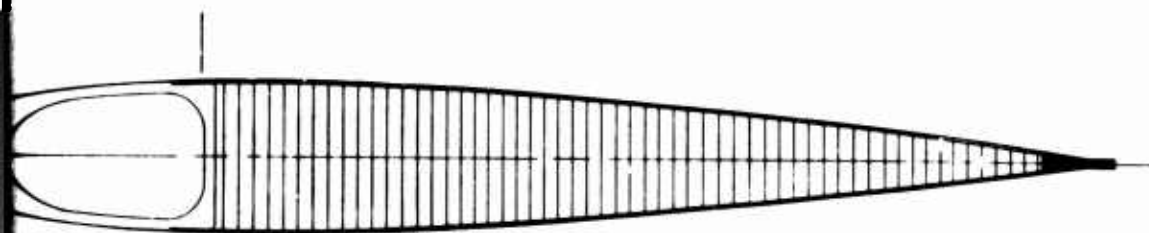
Figure 10. Configuration IV, Repairable Rotor Blade Using Composite Material Spar.

SECTION AT ROOT END

OUTBOARD SECTION

### DESIGN CONSIDERATIONS

1. BASIC BLADE STRUCTURE MADE ENTIRELY OF DIRECTED GLASS FILAMENTS FOR IMPROVED REPAIRABILITY.
2. ROOT END RETENTION AND DOUBLERS REINFORCED WITH TITANIUM PLATES.
3. INTRODUCTION OF AIRFOIL VARIATIONS POSSIBLE.
4. TORSIONAL STIFFNESS DIFFICULT TO ACHIEVE.

This design, illustrated in Figure 10, uses unidirectional glass fiber as the primary structural material for main spar and trailing-edge spline. A relatively heavy wall spar is required with a layup schedule that will provide the integral root end buildup along with adequate bending and torsional stiffness. At the root of the spar, titanium doubler plates are incorporated into the layup to provide improved bearing strength and resistance to splitting. Edges of the doubler plates are beveled to minimize disturbance of filament load path. Titanium grip plates are also provided at the retention and drag pin holes, top and bottom surface. Leading-edge ballast is bonded to the front of the "D" shaped spar and encapsulated by the protective sheath. Ballast weight is brass outboard but is replaced with unidirectional fiberglass inboard, which contributes significantly to edgewise stiffness. The leading-edge erosion protection is provided by a segmented sheath and has the same material options described for Configuration I.

At the blade root, a machined fitting connects the main retention pin and drag brace pin. External skin doublers also provide connection as well as improving local skin shear strength. The trailing-edge spline is made up of a "V" of fiberglass cloth which houses a wedge of unidirectional material. The aft segment of the wedge is glass fiber and runs from root to tip, while the forward segment uses carbon filaments which run from the root and taper out at station 140. Carbon is used also for inboard spar doublers, which are replaced by glass doublers outboard of station 120. This limited use of advanced composite material is significant in attainment of the desired natural frequencies at minimal increase in weight and cost of the blade. Blade skins and honeycomb are similar to those used in Configuration I but incorporate a more extensive doubler system in the basic skin layup at the blade root.

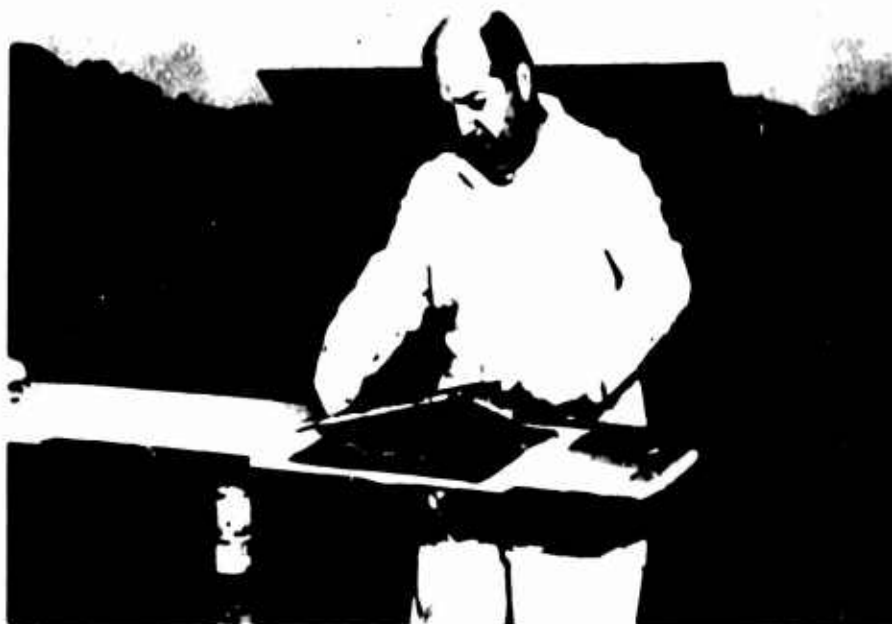
Figure 33. Inserting Repair Section.

11. Position repair section into hole in blade and tape in place with 2-inch-wide green Mylar tape, straddling the joint edge along 4 sides (Figure 33).

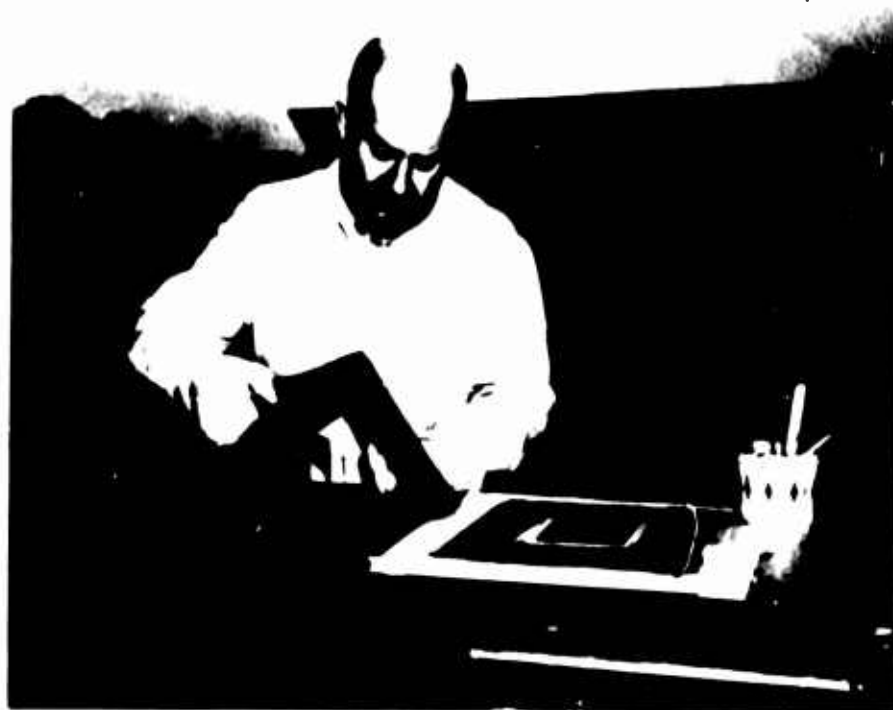
Figure 34. Removing Peel Ply From Doubler.

14. Remove the protective peel ply from the bonding surface of the picture frame doubler and spread adhesive with the serrated spreader (Figure 34).

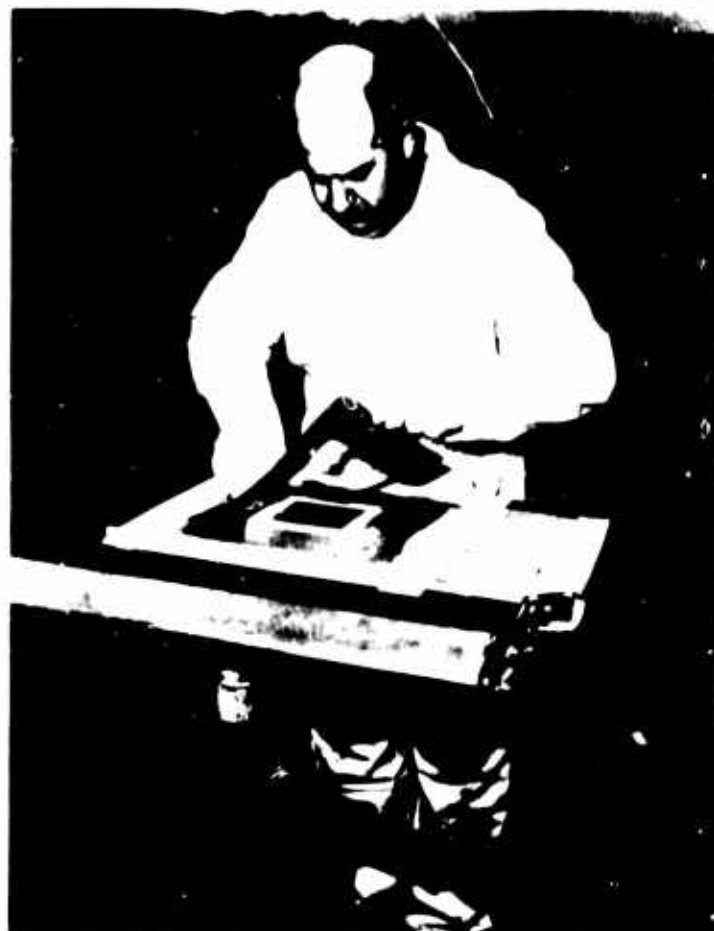
Figure 35. Positioning Doubler.

15. Position the doubler over the core plug joint and tape in place by 2-inch-wide green Mylar tape straddling the joint on all edges (Figure 35).
